Geological background for slope failures induced by the 2008 Wenchuan earthquake

Masakatsu Sasada, Yasunori Ootsuka, and Xu Wu

Abstract

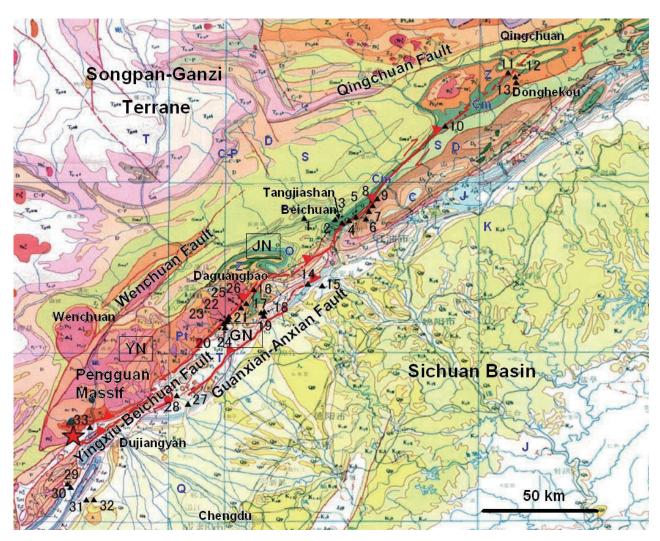
Fig. 1 Geological structures, surface ruptures and debris dams along the Longmenshan Fault Zone

Geology is referred from Geological Map of Sichuan Province of the People's Republic of China 1:1,000,000 (1991) ¹⁰⁾. Abbreviations of the geological eras and periods (blue letters): Pt: Proterozoic, Z: Sinian, Cm: Cambrian, O: Ordovician, S: Silurian, D: Devonian, C: Carboniferous, P: Permian, T: Triassic, J: Jurassic, K: Cretaceous, Q: Quaternary.

Surface raptures of the 2008 Wenchuan earthquake are referred from Xu, X. et al., (2008) ⁵⁾. Surface rapture is indicated by solid red line. Distribution of debris dam is based on location map of debris dams (Yin et al., 2008¹¹⁾). Debris dams are indicated by solid triangle. Nappes along the Longmenshan Fault Zone are indicated in abbreviations in an open square: YN: Yingxiu Nappe, JN: Jiudingshan Nappe, GN: Guanxian-Anxian Nappe.

Epicenter is indicated by red star.

The Longmenshan Fault Zone is located along the boundary between the accretion prism of Triassic flysch sediments of Songpan-Ganzi Terrane in the Tibetan Plateau, and the Proterozoic basement and its overlying sediments of the Sichuan Basin in the Yangtze Craton (Fig. 1). The Yangtze Craton is one of the oldest continental crusts in China (Burchfiel et al., 1995).

Nappe. It is mostly occupied by the *Pengguan Massif*, which consists mainly of the Proterozoic granitic rocks and highly metamorphosed rocks of green schist and amphibolites facies (Fig. 1). The mylonitic rocks are distributed along the Yingxiu-Beichuan Fault and the Wenchuan Fault (Hou et al., 1995¹²⁾; Xu, Z. et al., 2008⁶⁾). The Pengguan Massif is the oldest geologic unit in the Longmenshan Fault Zone, indicating intensive upheaval and erosion through the thrust movements. The mountain slope of the Pengguan Massif is the steepest in the Longmenshan Fault Zone (Photo 1).

The nappe thrusted up by the Yingxiu-Beichuan Fault in the northeastern region is called the Jiudingshan Nappe (Fig. 1). It consists mainly of Sinian, Cambrian, Ordovician, and Silurian sedimentary rocks. The dolomite and limestone are present in the Sinian formations. The anticline and syncline structures are developed well with the axis parallel to the Longmenshan Fault Zone (Burchfiel et al., 1995).

and associated debris flows resulted in debris dams especially along the Yingxiu-Beichuan Fault (Fig. 1). The debris dams were numbered 34 on June 15, 2008 just after the earthquake, and another 70 debris dams were found in the Sichuan Province, after that. The large debris dams like that of Tangjiashan were trenched to prevent breaching. Distribution of debris dam may mostly reflect distribution of the large slope failures relating to the earthquake.

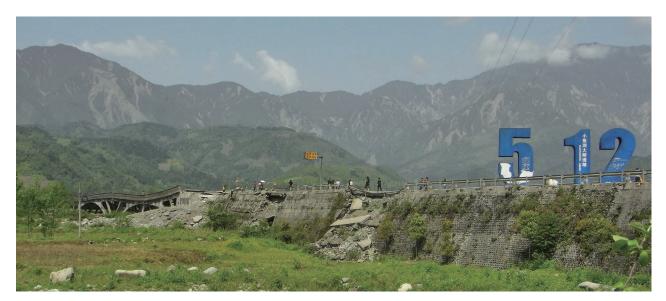
Photo. 1 The steep topography of the southeastern slope of the Longmenshan mountains.

The photo was taken at Xiaoyudong, where the bridge was collapsed as a result of the earthquake. There are so many slope failures on the mountain of granitic rocks of the Pengguan Massif.

The reason why the Pengguan Massif is characterized by very steep slopes (Photo 1) is recent intensive upheaval and erosion which was resulted from the repeated thrust movements along the Longmenshan Fault Zone. Such tectonic movement is associated with subsidence in the Sichuan Basin side, which is called a foredeep. The thick Quaternary sediments are deposited in the foredeep in the Sichuan Basin just in front of the Pengguan Massif (Burchfiel et al., 1995⁹⁾; Jia et al., 2006¹⁵⁾).

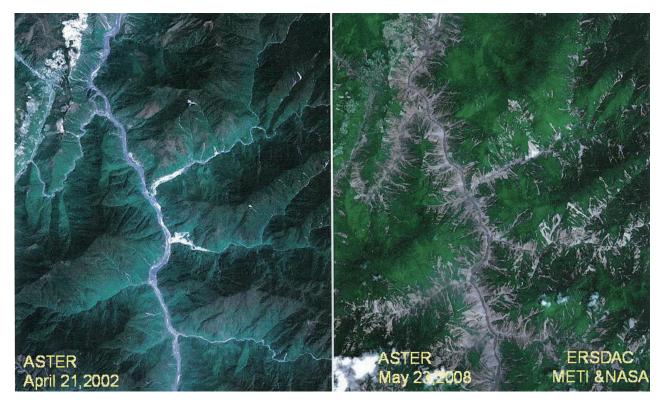
Photo. 2 Satellite imageries before and after the 2008 Wenchuan earthquake.

Location is near the city of Wenchuan. Slope failures are remarkably observed after the earthquake along the valley where the granitic and metamorphic rocks of the Pengguan Massif are exposed. These imageries are cited from "Topography of the earth viewed from the space" (Kato, 2010) ¹⁴⁾.

As shown on the satellite imageries (Photo 2), the slope failures occurred mostly at the steep skirts of the mountains along the valleys. The strong motion of the earthquake detached the rocks from the slopes, and rock avalanches happened on steep and unstable slopes in the Pengguan Massif of granitic and highly metamorphosed rocks (Photo 3).

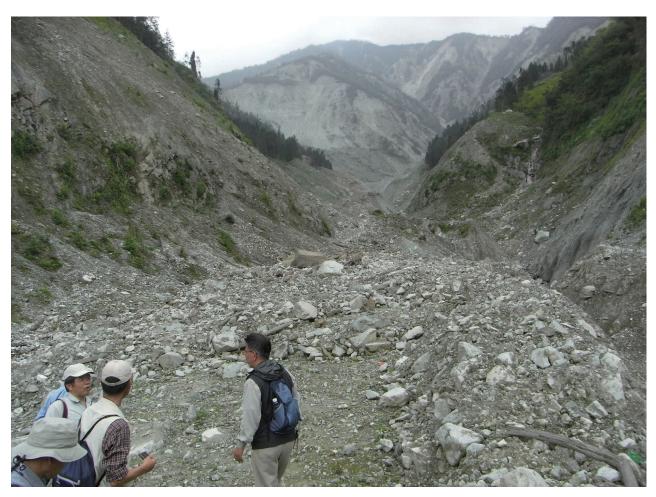
Photo. 3 Rock avalanche occurred near the epicenter of the earthquake to the west of Yingxiu.

Debris of the granitic rocks are thickly deposited along the valley. The Proterozoic granitic rocks of the Pengguan Massif are exposed on the slopes ahead.

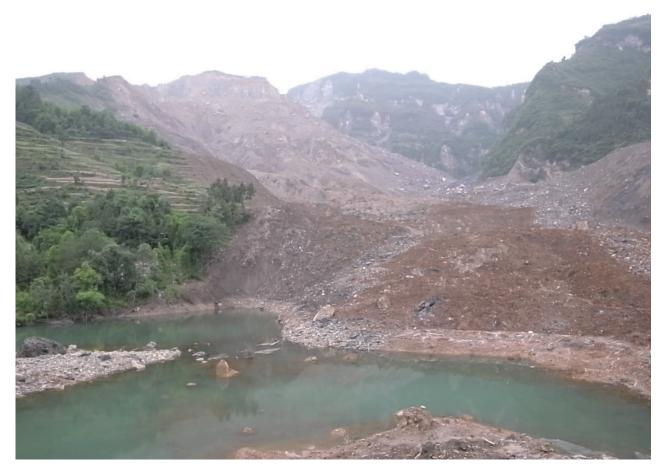
Photo. 4 Landslide and debris flow at Donghekou

The sliding mass and debris of sedimentary rocks blocked the Hongshihe River.

The Donghekou 'landslide and debris-flow' occurred at the fault zone in which Cambrian slate

and phyllite and Sinian dolomite and limestone appeared (Fig. 1 and Photo 4). This landslide was mainly affected by a fault trending of N50°E and 80-100 m wide. The total length of run-out is about 2400 m (Sun et al., 2009^{18}).

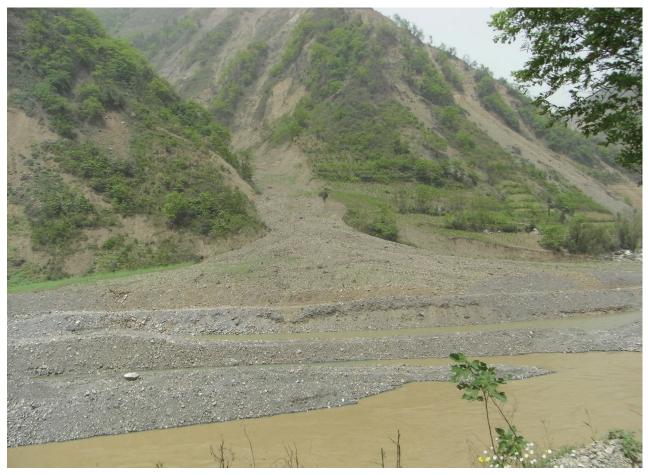
Photo. 5 Secondary debris-flow deposit to the east of Beichuan.

Debris-flow was triggered by the heavy rain precipitated three months after the earthquake.

Some debris flows deposits are the results of secondary movement of debris from rock avalanches and landslides (Photo 5). Both of the Pengguan Massif and the Jiudingshan Nappe especially along the Yingxiu-Beichuan Fault have high potential of such debris flows. They might block a river, and the debris dam itself has a risk of breaching. On the other hand, rock fall is a potential disaster on steep slopes especially in the massive rock dominant region where the granitic rocks or thick pile of sandstones are distributed.
